# LMS2, Service Bulletin, IO Module Connectors

## Description of Service Bulletin

- LMS2-LASX060 – IO Module

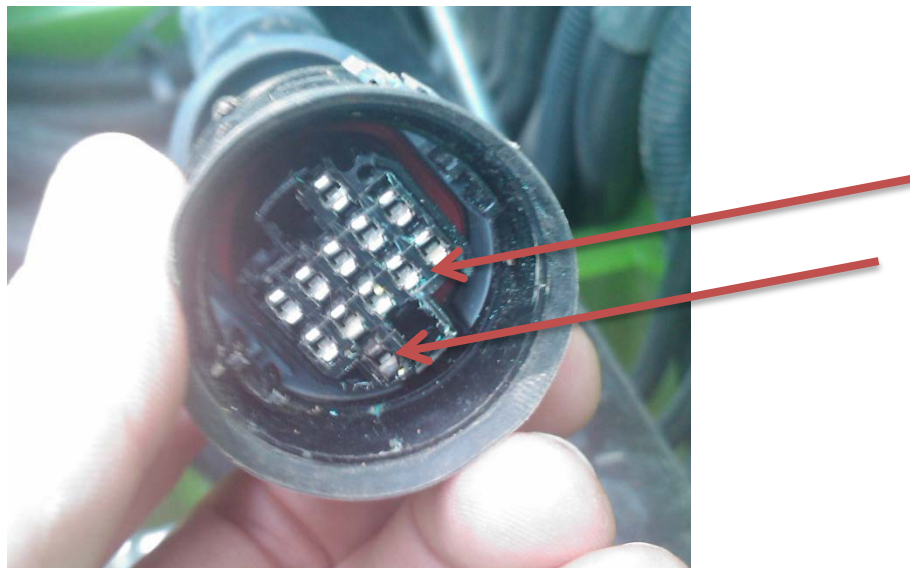
The above image shows blue copper oxide around the connectors as well as one connector pin badly tarnished. In this instance the connector must be changed, cleaning will not suffice.

In any instance that the integrity of the electrical connector is compromised, especially the 4 pin power connector, the entire connector must be replaced with a suitable replacement connector.

In the event of corrosion of the pins, it is unacceptable just to clean one connector as both ends of the connector will suffer the same problem.

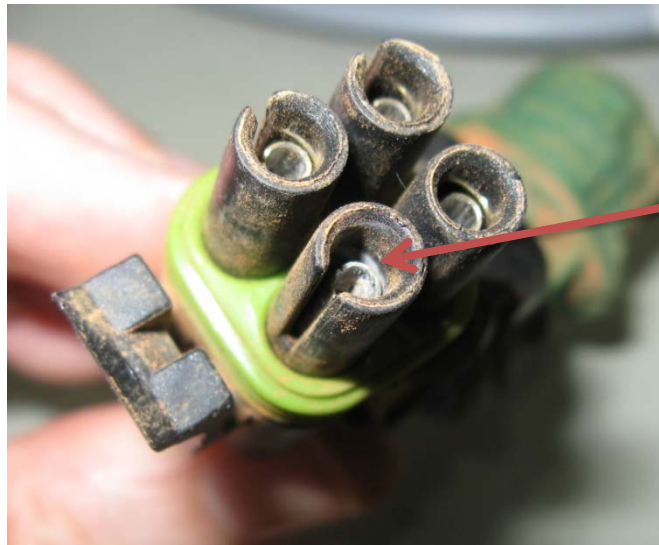
In the above instance the connector pin (PIN B – Main power pin) was corroded. Without careful inspection this fault was missed. The unit reported sensors failing and an un-reliable display module. The fault inspection determined that the electrical pin had a large voltage drop across it causing the LMS system to lose power.

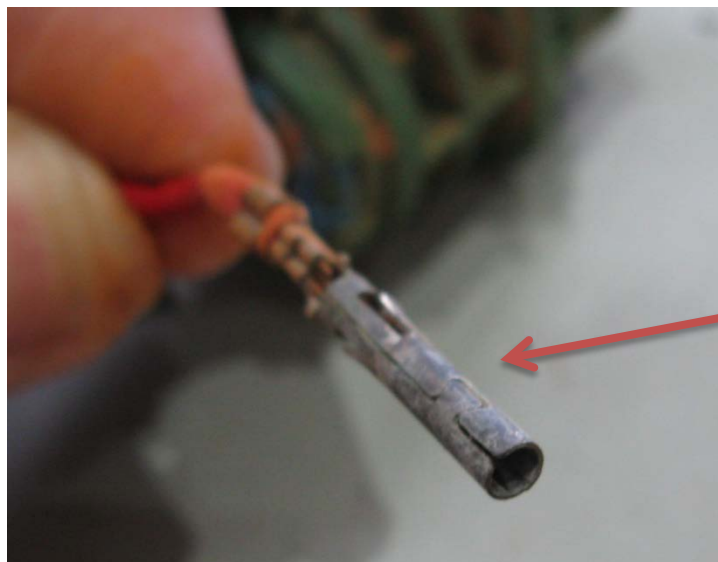
The above instance shows a crimp terminal that is tarnished. This causes a voltage drop across the connector, or total loss of LMS power.

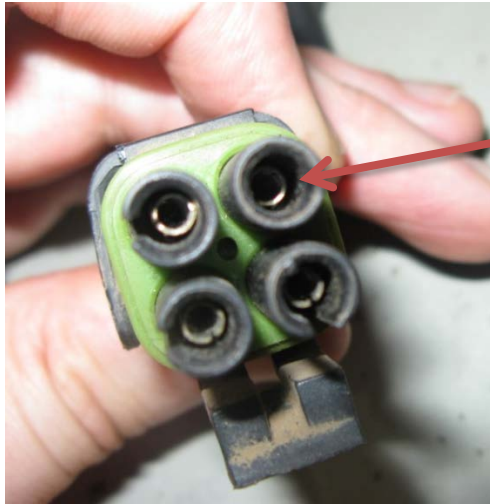
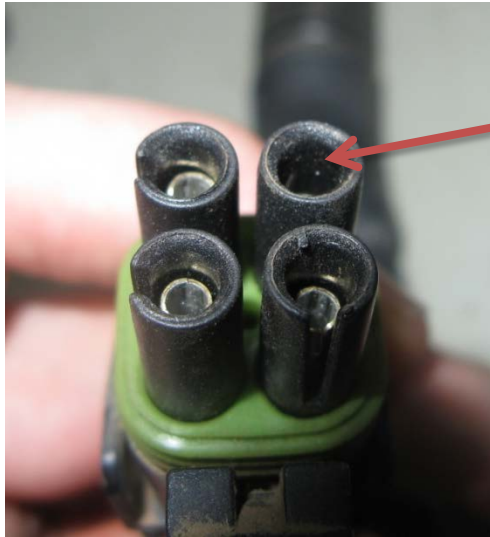
In the above example a connector pin has been backed out of the connector. This causes an intermittent electrical connection and loss of display power. The IO Module was returned for warranty however no faults other than the connector were found.
